Manhole Inspection Summary

Manhole # S37WW_026MH

Insp Date: **1/10/07 9:19 AM**

Location Address: **611 30TH ST**

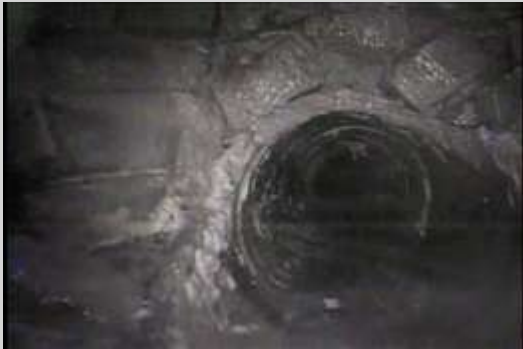
8 in. Circular Gravity Sewer Pipe Out @ 12 O'Clock

Pipe Material: **Clay** ☐ Pipe Lined

Invert Depth: **11.05** (ft.) Flow Characteristics: **Slow**

Deposits: ☒ None ☐ Mud ☐ Sludge ☐ Debris ☐ Grease

Infiltration: **None** Pipe Seal Cond: **Unknown**

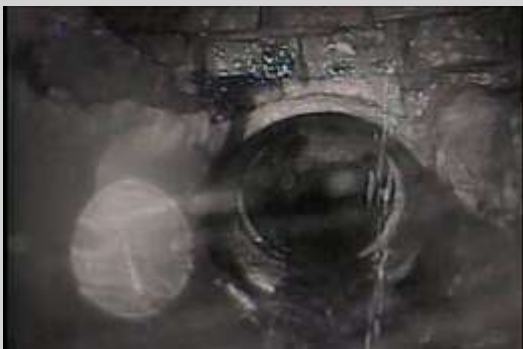
8 in. Circular Gravity Sewer Pipe In @ 6 O'Clock

Pipe Material: **Clay** ☐ Pipe Lined

Infiltration: **None** Pipe Seal Cond: **Unknown**
